Winton House Access Report 17.06.2014

Stoke-on-Trent Area Network for Disability STAND was asked to look at access issues at Winton House following a complaint by one of our members.

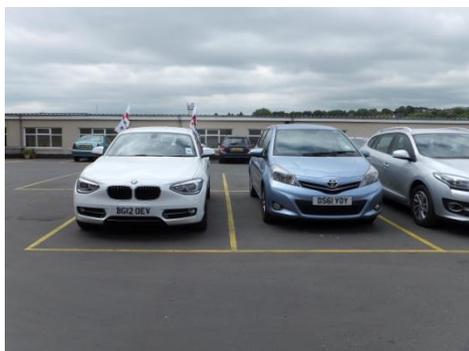
STAND originally objected to the planning application 55670 for Capita to use this building because they were only designating one disabled bay for dedicated, disabled visitors' parking. When we visited there was NO dedicated, disabled parking. There were two parking spaces on the top car park, for staff.

However none of the spaces on this car park would be suitable for disabled people as there are steps to both of the access doors.

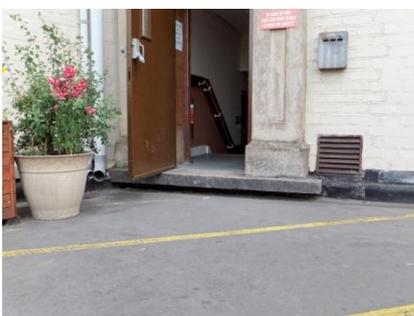
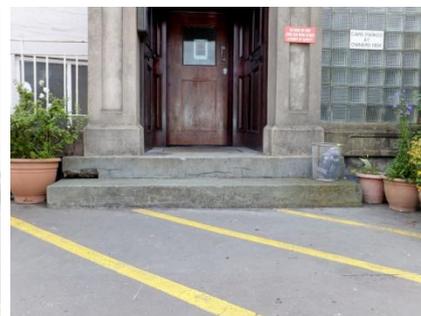
There are also stairs once inside the building making it totally inaccessible to anyone with mobility problems, breathing difficulties or a heart condition.

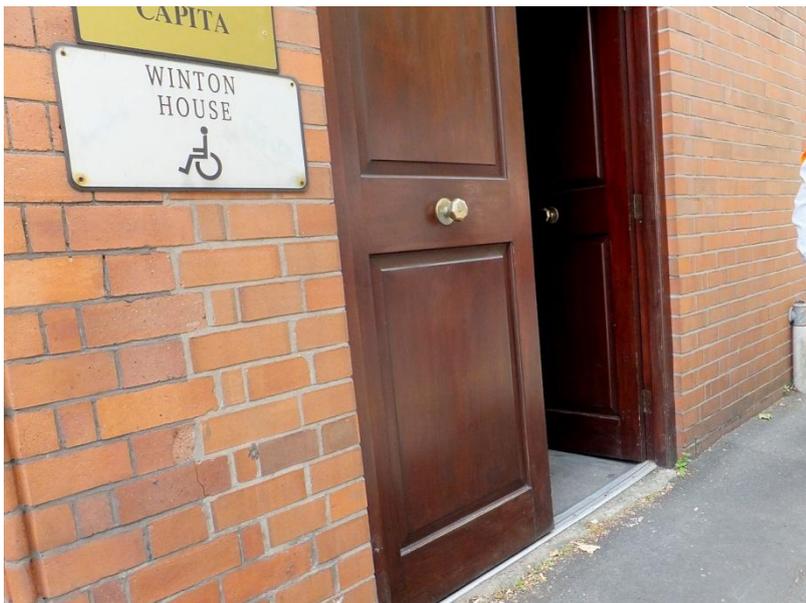
Access to Winton House from the road.

The disabled access door had been pointed out to us by the very efficient car park attendant. There was a small sign which indicated that was where we were supposed to enter.

The journey to the assessment rooms was far in excess of the 20 metres and probably more than the 50 metres. There was no help button to get someone to open doors or bring a wheelchair. There were 5 sets of heavy, doors to go through which would cause considerable problems for someone with upper body problems or limited mobility, meaning

that they have to use a stick, crutches or frame as they would find it difficult to balance while trying to open and hold these heavy doors. Some of these doors open inwards, making it even more difficult. A person trying to use a wheelchair independently would catch their hands on the door frame as the self propel through the single doors and how do they self propel and hold two, heavy, doors open?

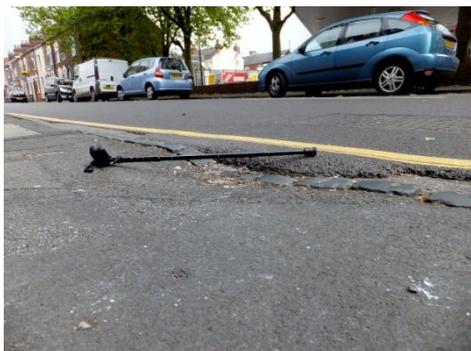
Another safety issue is the state of the pavement outside the door at this point. If a wheelchair user caught their wheel in this hole it could tip them out and cause some more problems. It also causes a significant danger to visually impaired people.
